SIB 01 12 19

2020-10-30

FRONT GRILLE UPPER/LOWER ACTIVE AIR FLAPS: LTD WTY EXT TO 15 YEARS/150,000 MILES

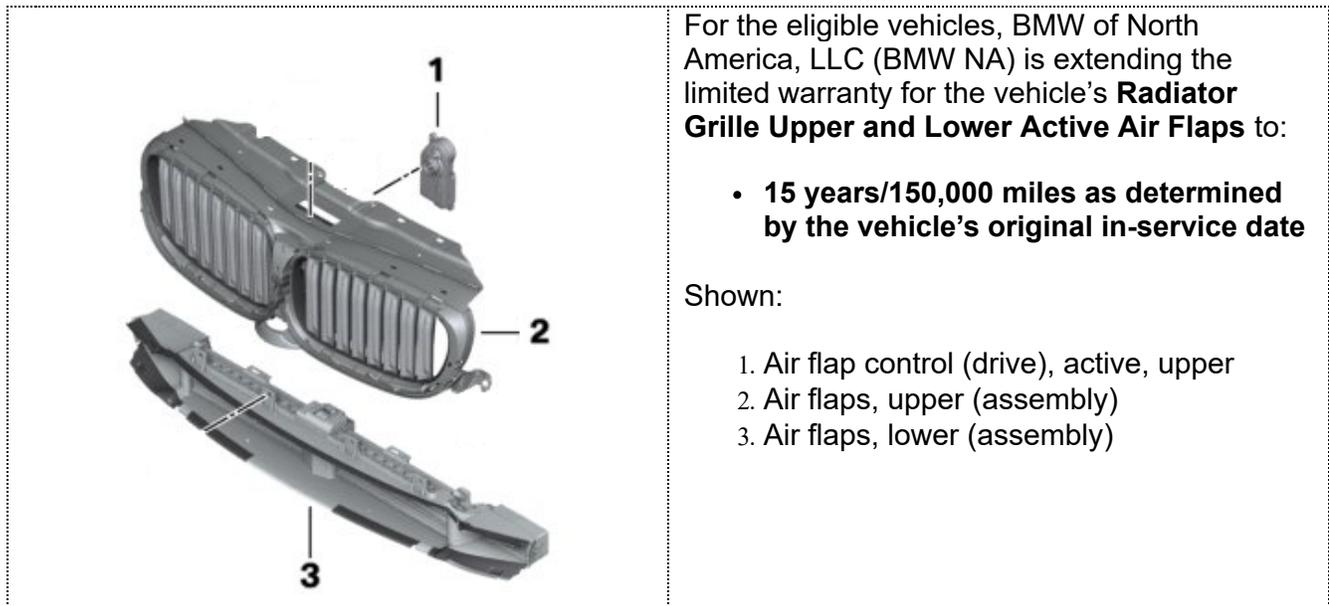
Component-Specific Limited Warranty Extension

This component-specific limited warranty extension applies to defects in materials or workmanship.
