SI B34 05 17
Brakes

TICKING NOISE WHILE CORNERING WITHOUT THE BRAKES APPLIED

This Service Information bulletin replaces SI B34 05 17 dated June 2017

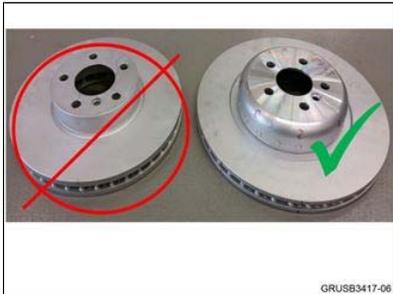
<ol style="list-style-type: none"> 1. Verify noise is being produced when the brakes are NOT being applied. 2. Check which type of brake disks are installed on the vehicle. Are the lightweight disks (as shown on the right) installed on the vehicle? YES- Go to Step 3. NO – continue diagnosis with ISTA. 3. Remove brake discs according to repair instruction 3411220 “Removing both front discs and installing and replacing”.
	<ol style="list-style-type: none"> 4. Clean the wheel bearing flange with brake cleaner
